Ultramark 4

ULTRASOUND SYSTEM

field service manual

Service Manual 4730-0001-06 Rev B consists of:

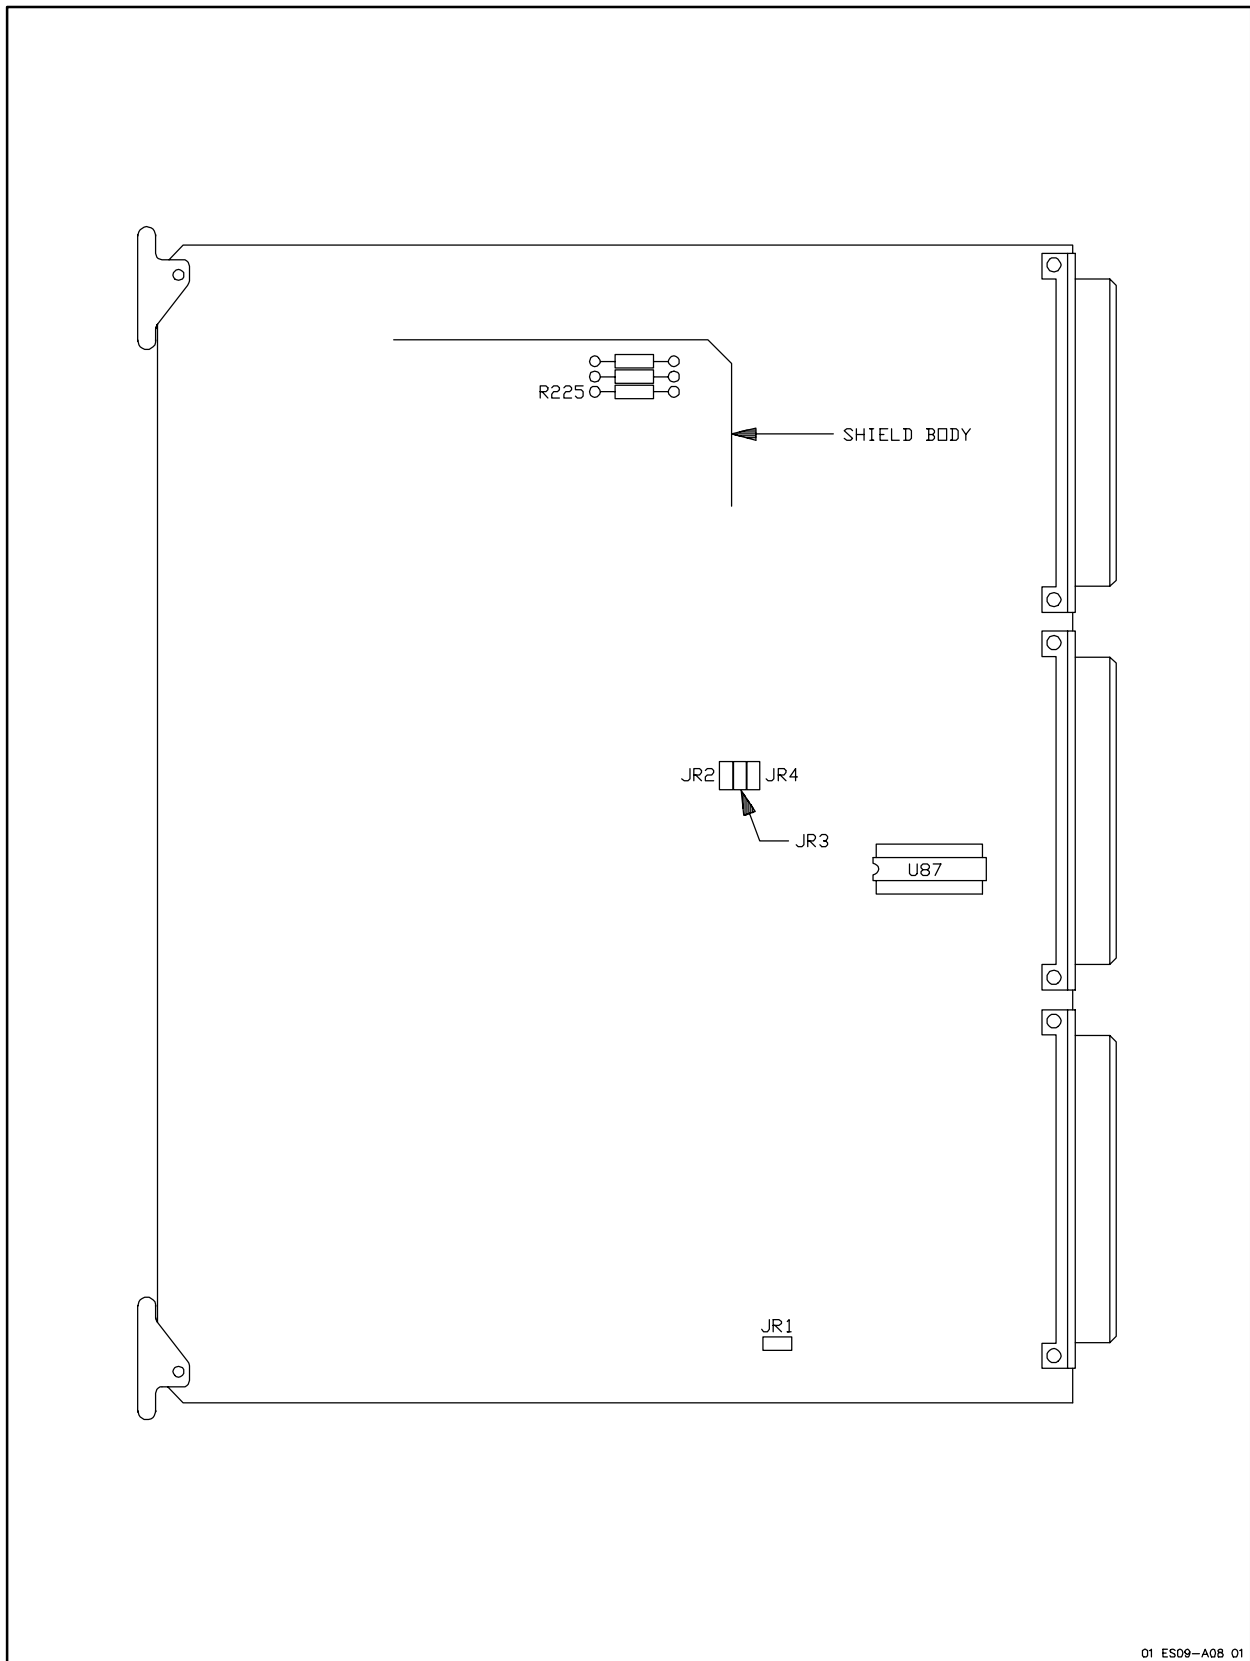
Figure VI. 7500-0346-XX PCB

1. Remove Doppler Acquisition shield (See [Figure VI](#)).
2. Remove R225 (if R225 is not mounted on solderable posts, cut the leads of R225 as close to the body of the resistor as possible and use the leads to mount the resistor in Step 3).
3. Replace R225 with a 237 OHM resistor, 2820-0074.
4. Replace Doppler Acquisition shield.
5. Using 4 100-0092 label or any available small blank stick-on label , mark the board as -01 .

COMMENTS: This change renders the PCB DADA compatible.

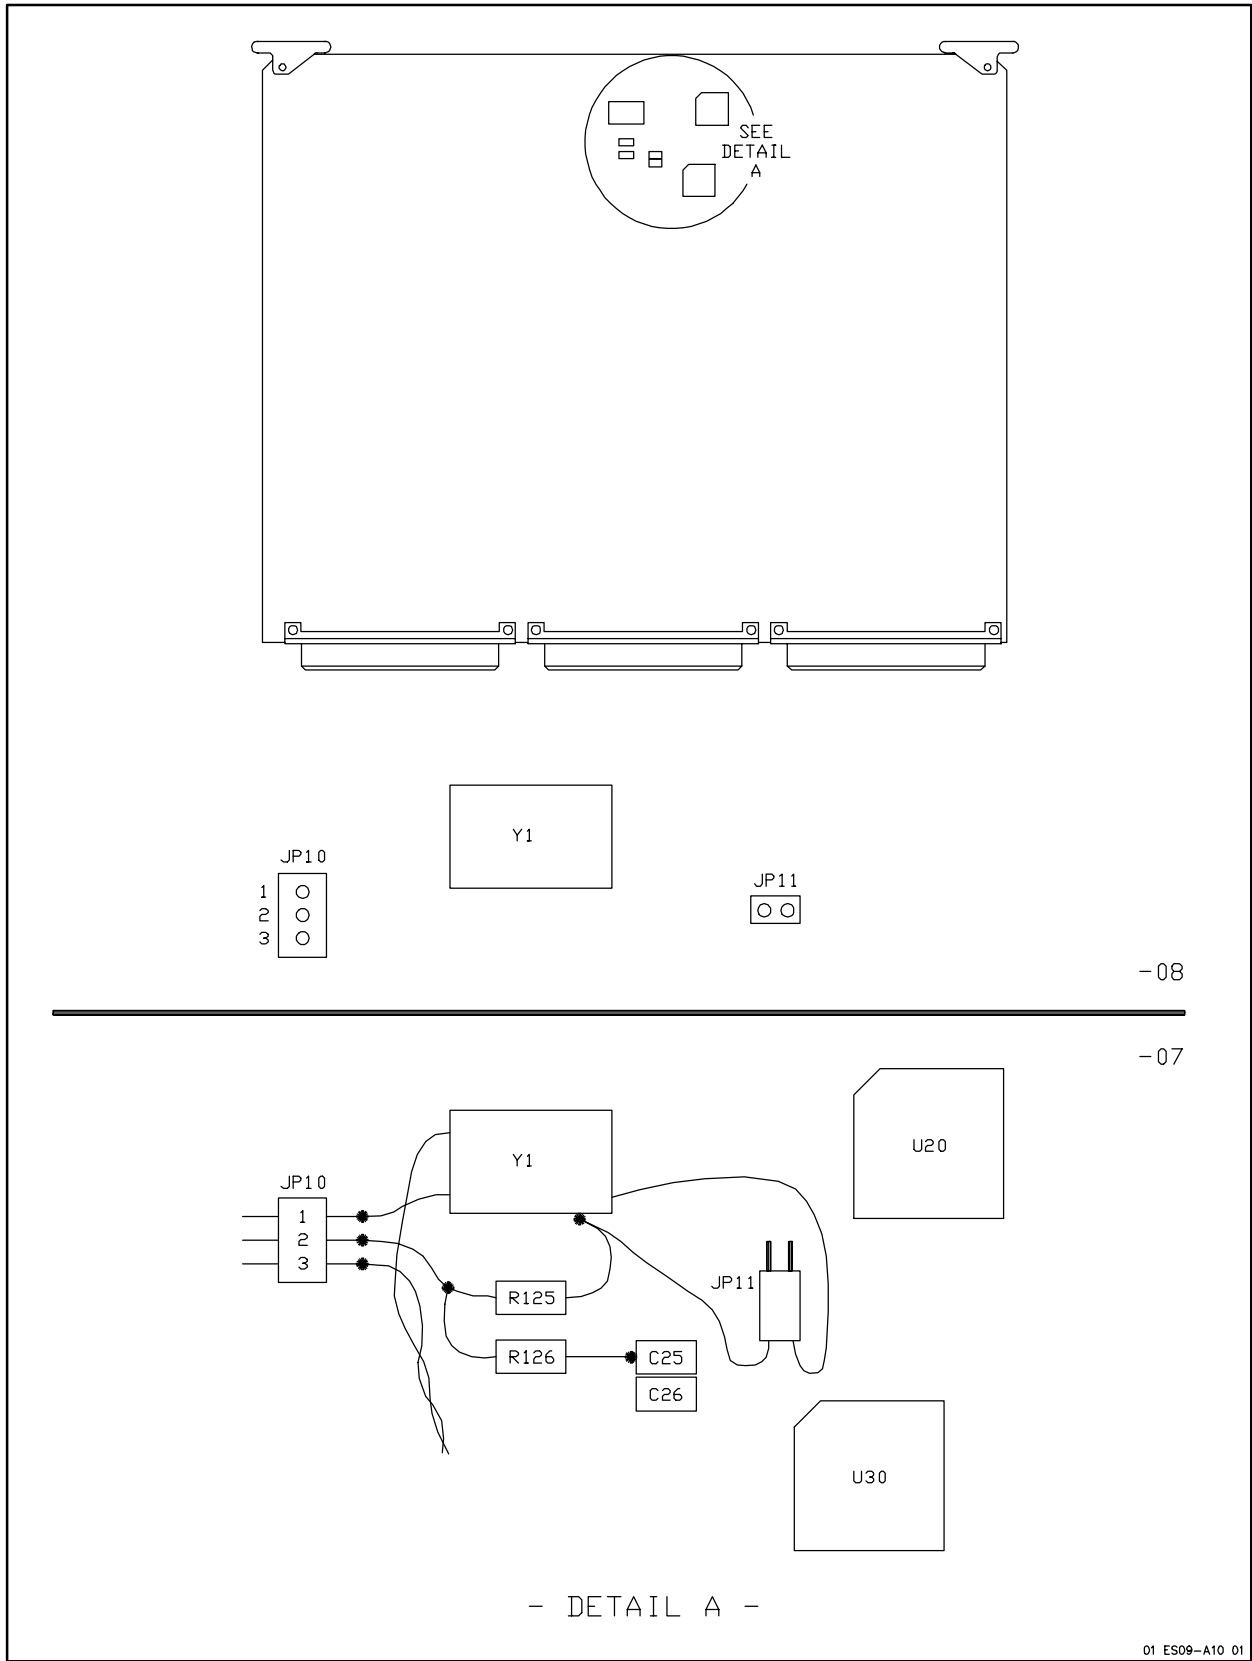
Figure VIII. 7500-0411-XX PCB

1. Install a header jumper at JP11 (see [Figure VIII](#)).
2. Move the jumper connector at Pins 2 and 3 of JP10 to Pins 1 and 2 of JP10.
3. Using 4100-0092 label or any available small blank stick-on label, mark the board as “Non-Sync” near the dash level indicator.

COMMENTS: This change renders the PCB as a Non-Sync type with its own independent clock.
